**US Army Corps  
of Engineers**

**Flood Control, Mississippi River and Tributaries  
Yazoo River Basin - Tallahatchie River  
Tallahatchie County, Mississippi**

**Ascalmore Creek - Tippo Bayou  
Item No. 3, Control Structure**

**FOUNDATION  
REPORT**

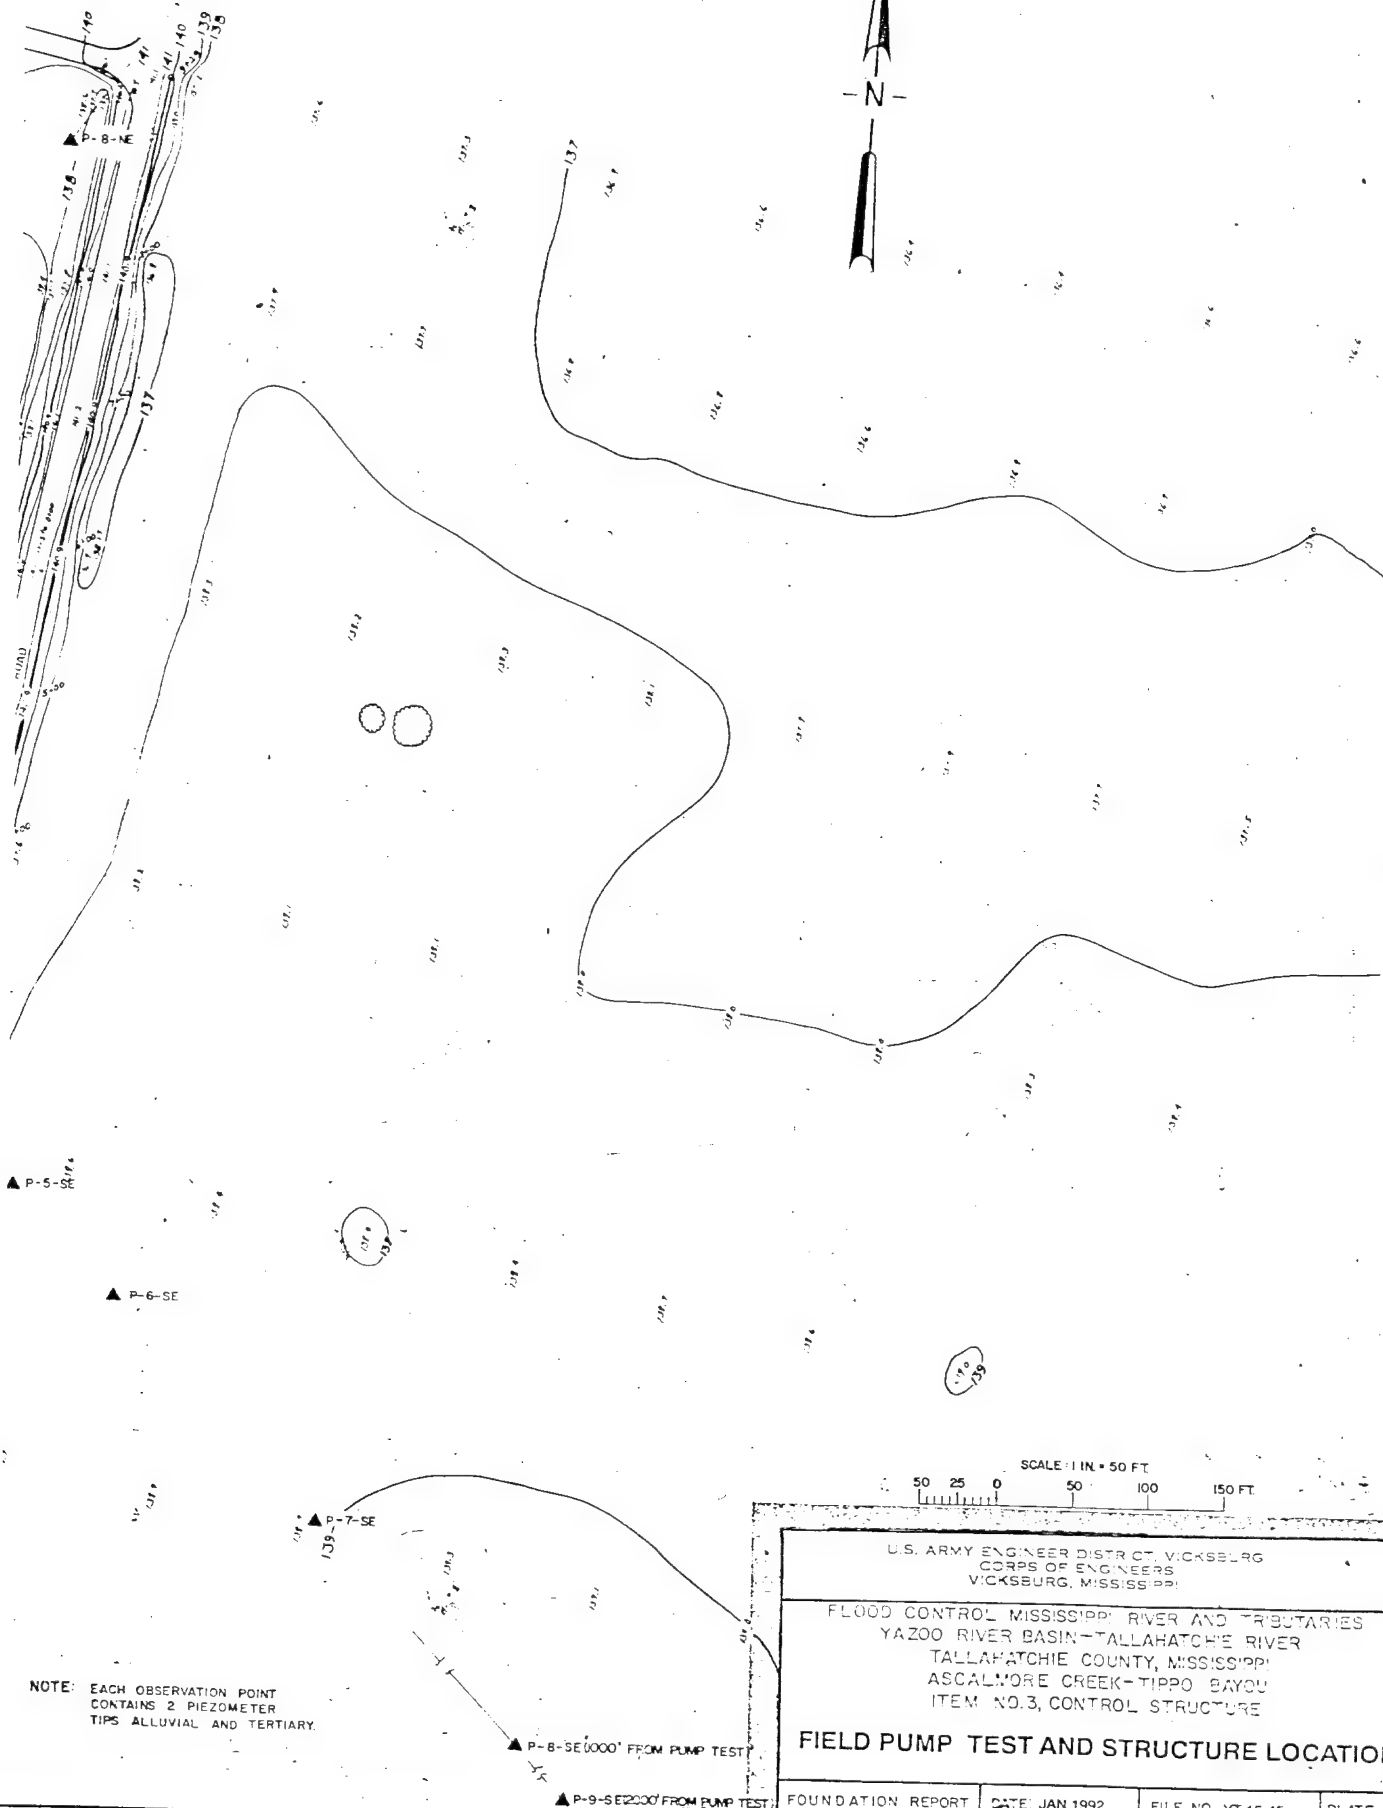
DATE JAN 1982  
 U.S. ARMY ENGINEER DISTRICT, VICKSBURG  
 VICKSBURG, MISSISSIPPI  
 SCALE AS SHOWN  
 PUMP TEST DATA  
 ITEM NO. 3, CONTROL STRUCTURE  
 FOUNDATION REPORT  
 AS CALMORE CREEK - TIPPO BAYOU  
 YAZOO HEADWATER PROJECT, MISSISSIPPI (TRIBUTARIES)  
 MISSISSIPPI  
 FLOOD CONTROL, MISSISSIPPI RIVER & TRIBUTARIES

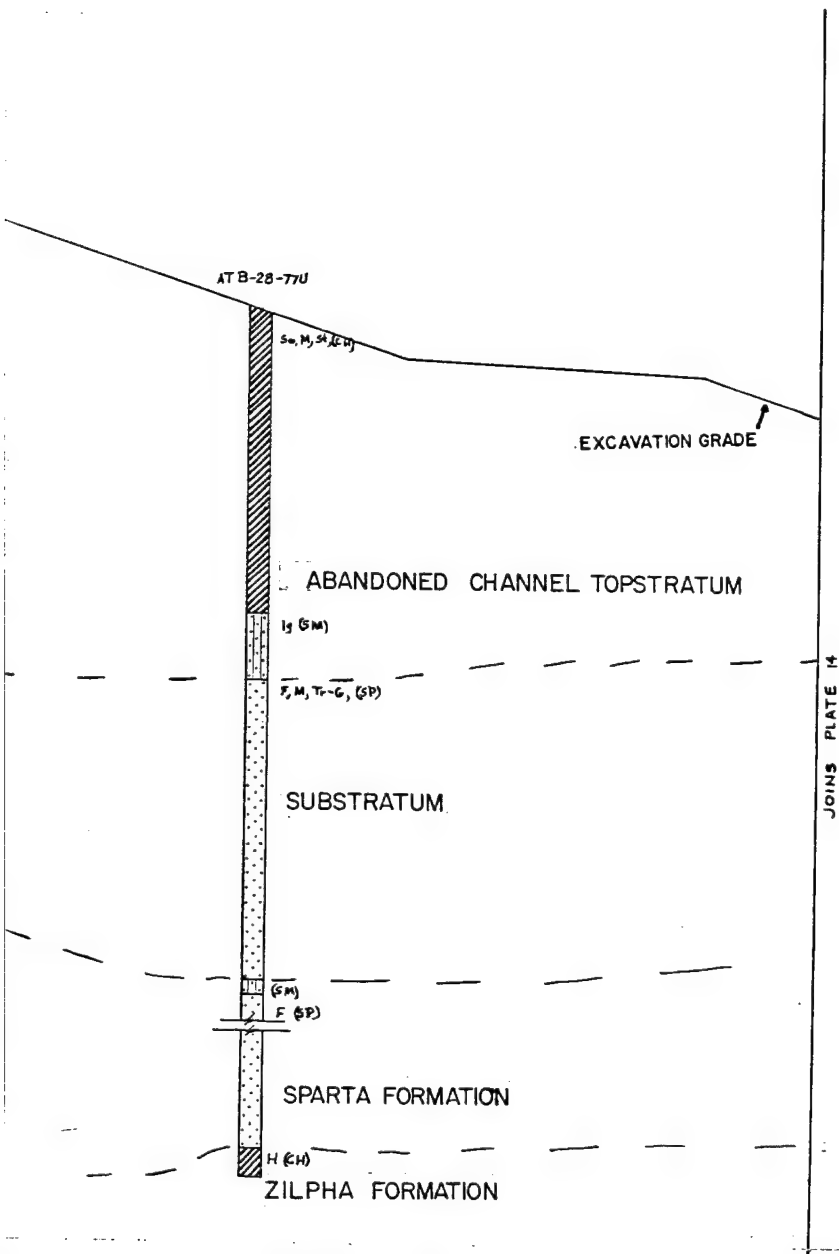
**GEOLOGIC PROFILE CENTERLINE CHANNEL  
A-A SHEET 1 OF 2**

1. For Locations of Sections, see dwg. 11
2. BORING LOGS ARE INTENDED TO SHOW GENERAL GEOLOGIC CONDITIONS. FOR COMPLETE BORING LOG INFORMATION SEE PLATES 5 THRU 9.

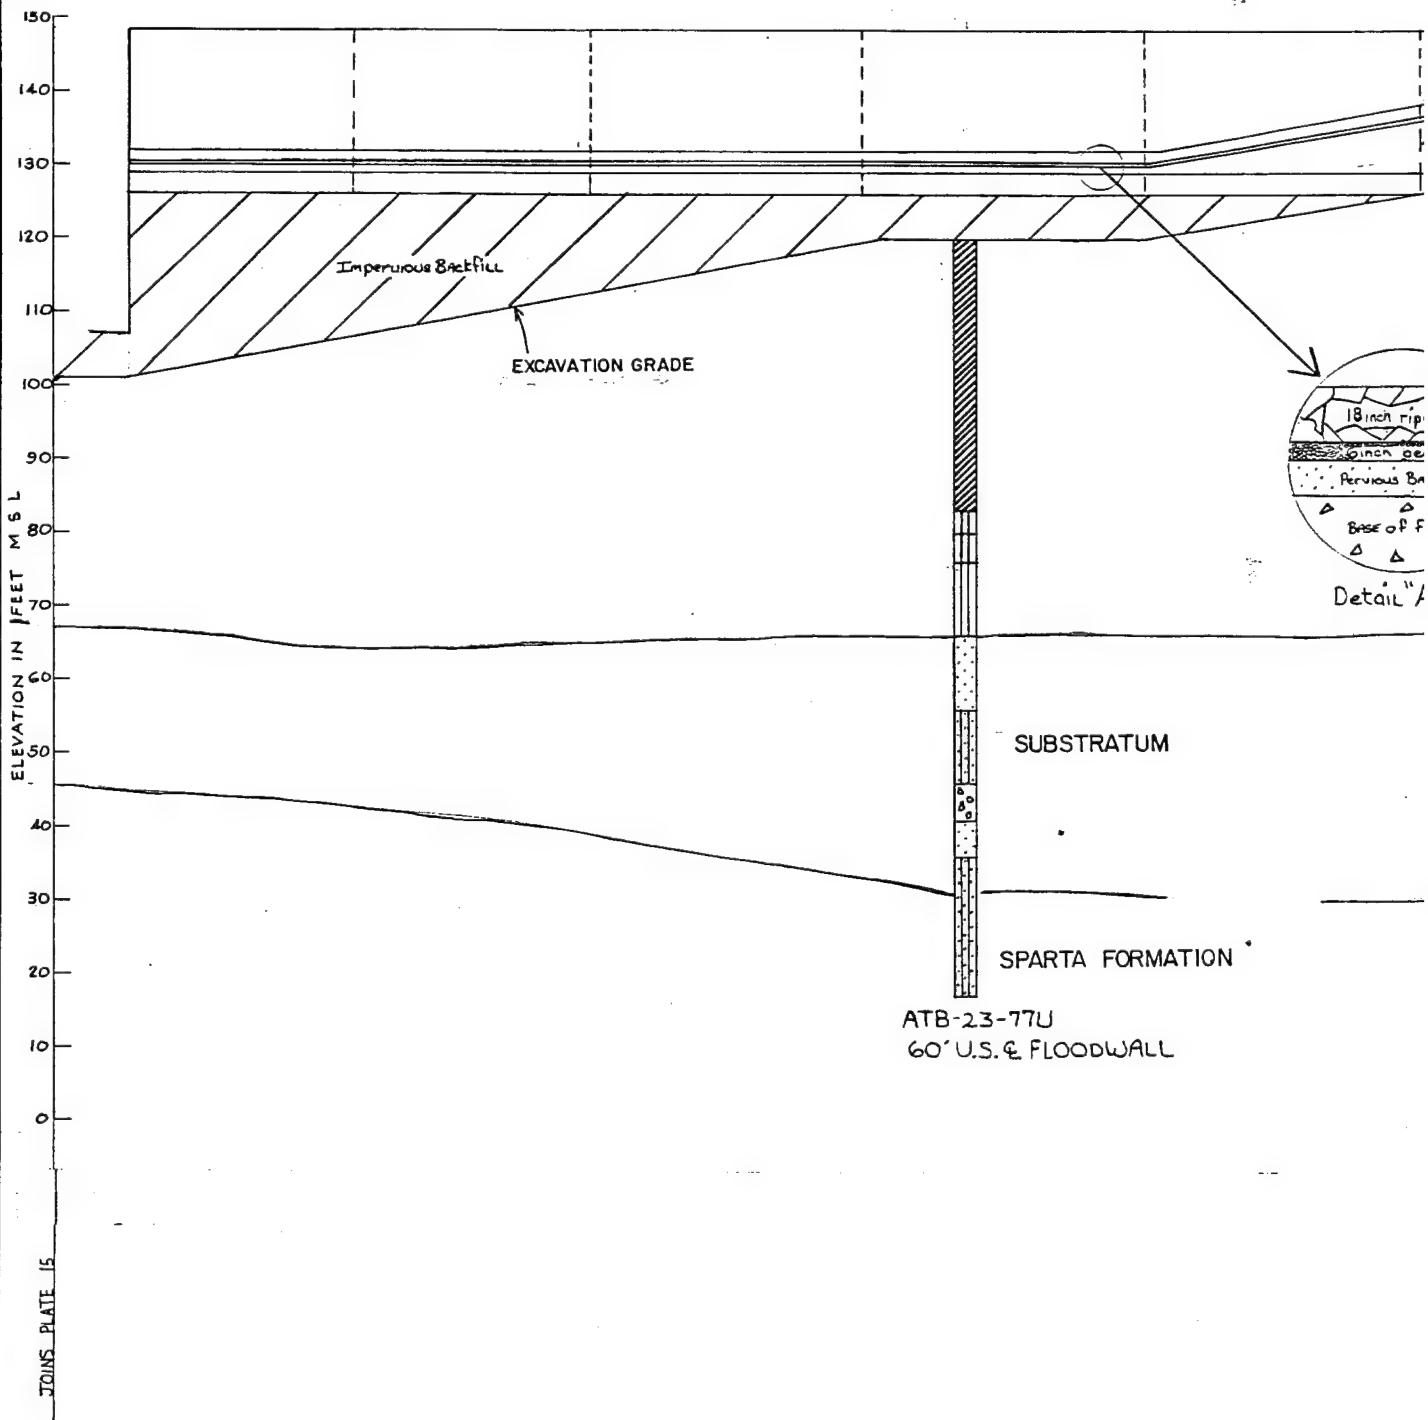
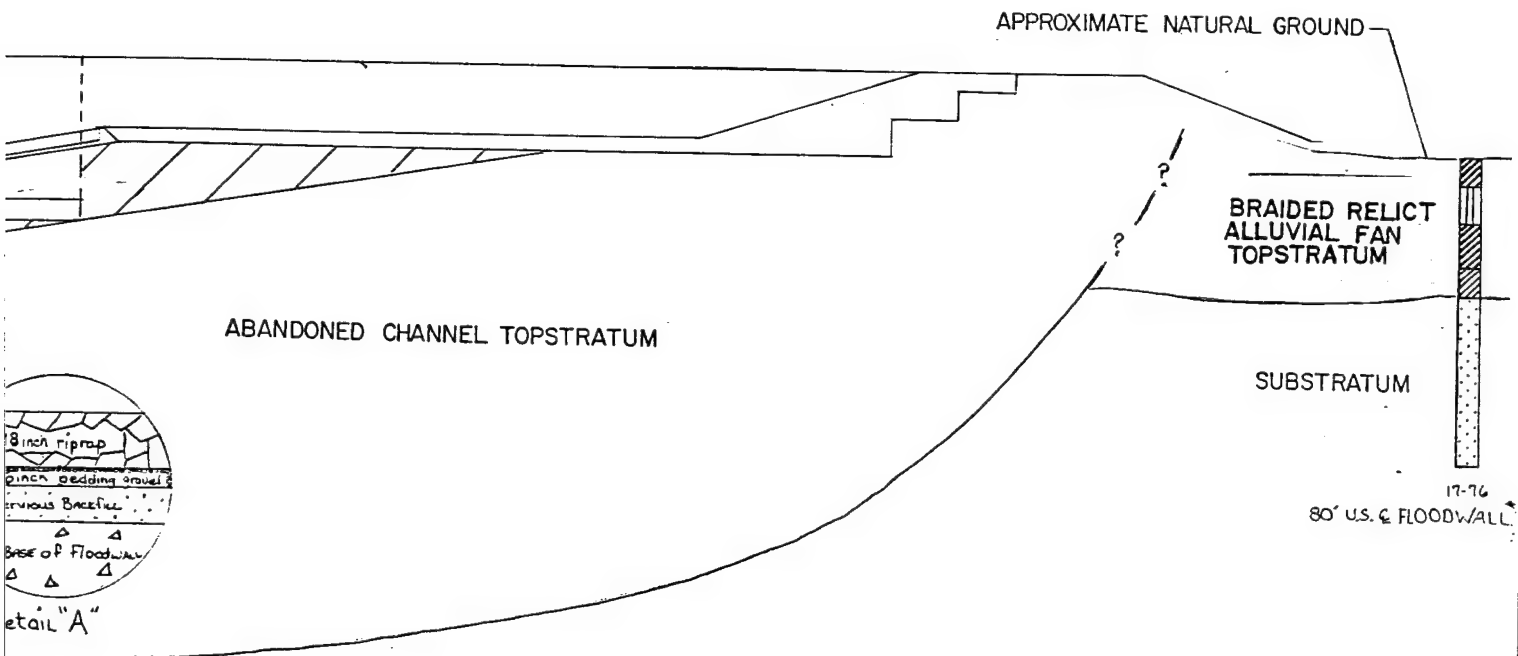
**GEOLOGIC PROFILE; S-FLOODWALL  
B-B SHEET 2 OF 2**

1. For Locations of Sections, see dwg. 17.
2. BORING LOGS ARE INTENDED TO SHOW GENERAL GEOLOGIC CONDITIONS. FOR COMPLETE BORING LOG INFORMATION SEE PLATES 5 THRU 9.

g. Floodwalls. A north and south floodwall extends from the approach monolith and ties into natural earth. The outermost portion of the floodwall consists of an I-wall which extends to an elevation of 148.5 feet. Individual monoliths and foundation grades for the floodwall are shown on Plates 14 and 15.

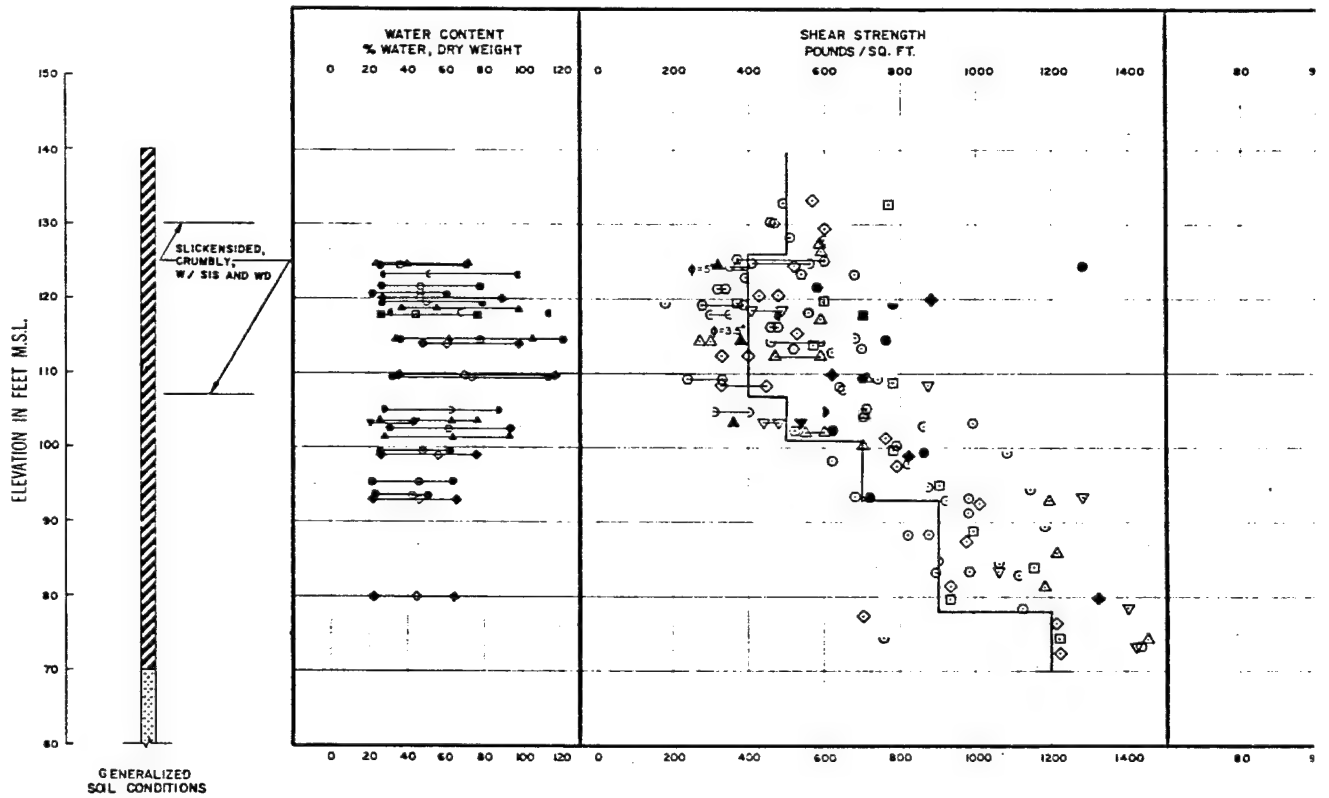
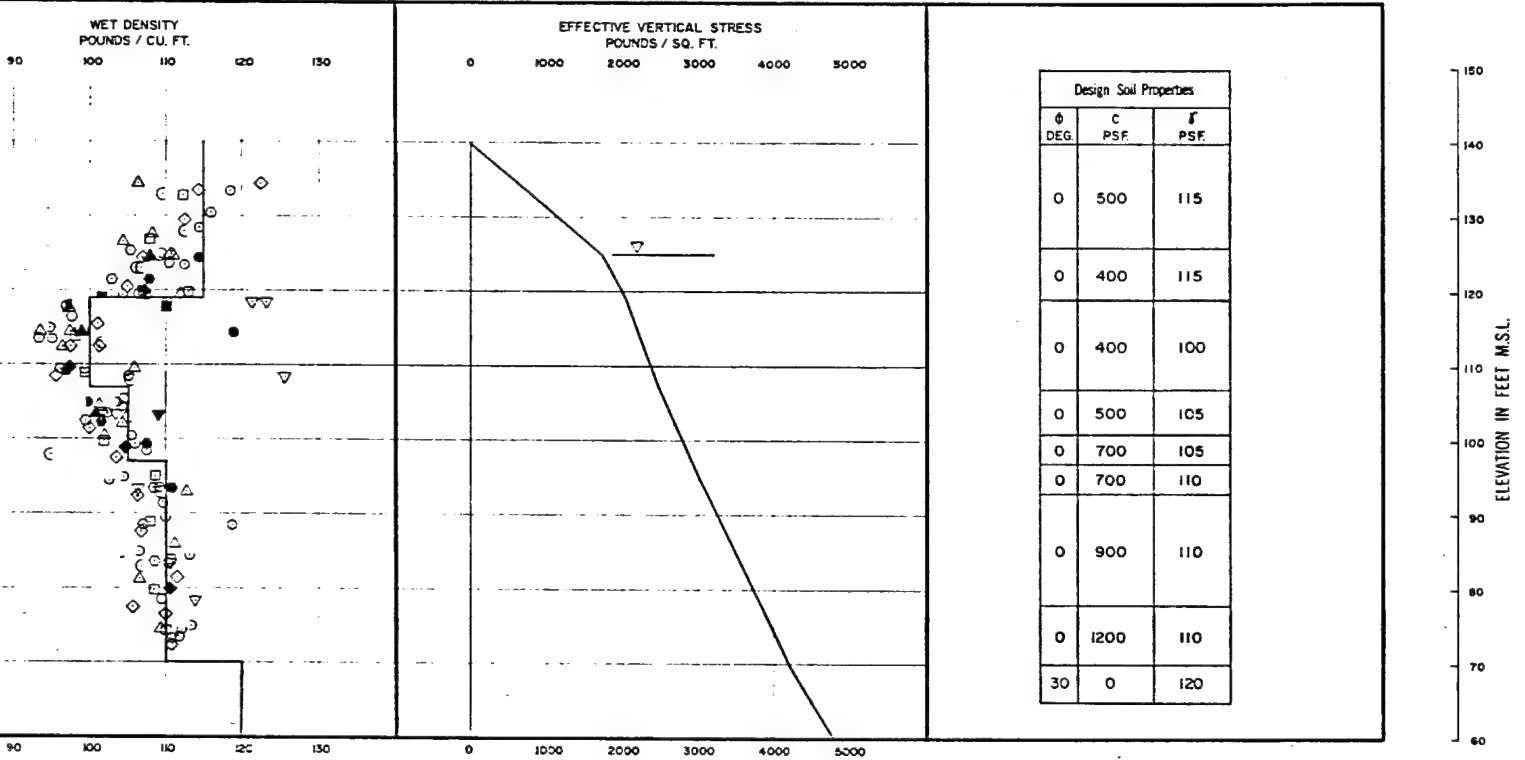
PLATE 16

BORING NO.	ENVELOPE NO.	EL.	STRENGTH $\phi$ C-PSF	CLASS
ATB-23-77U	1	120.4	19° 200	CH
	2	95.4	24° 260	CH
ATB-24-77U	3	118.5	16.5° 420	CH
	4	101.4	20° 0	CH
ATB-25-77U	5	114.0	15° 320	WH
	6	92.9	26° 0	CH
ATB-30-77U	7	123.0	16.2° 360	CH

a. Topstratum Clays. As noted above, the construction site was located in an abandoned channel "clay plug." An analysis of the laboratory tests, outlined in paragraph 2-01(d), indicated that the massive clay topstratum could be subdivided into eight zones based on the material's shear strength, Atterberg Limits, wet density, and water content. These zones are shown on Plate 16.

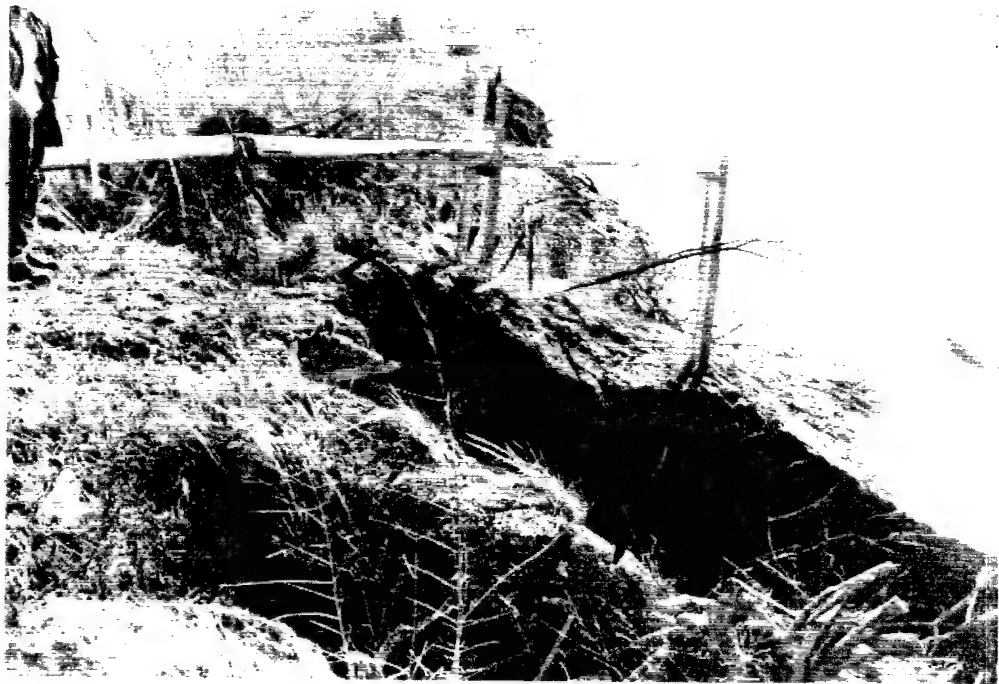
3. SLIDE AJACENT TO THE TALLAHACHIE RIVER

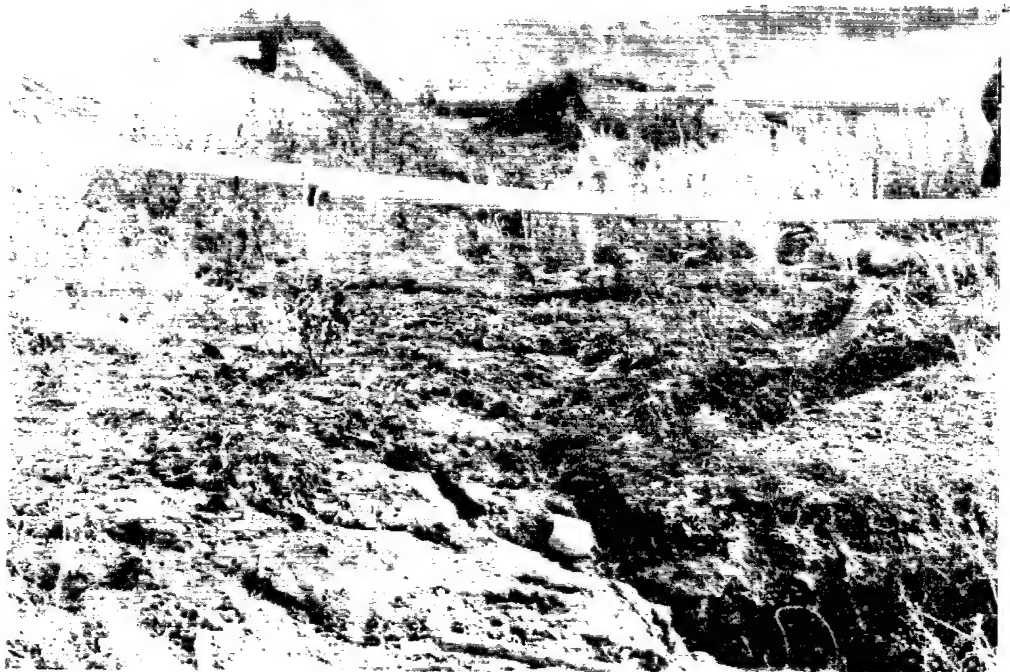
4. SLIDE AJACENT TO THE TALLAHACHIE RIVER

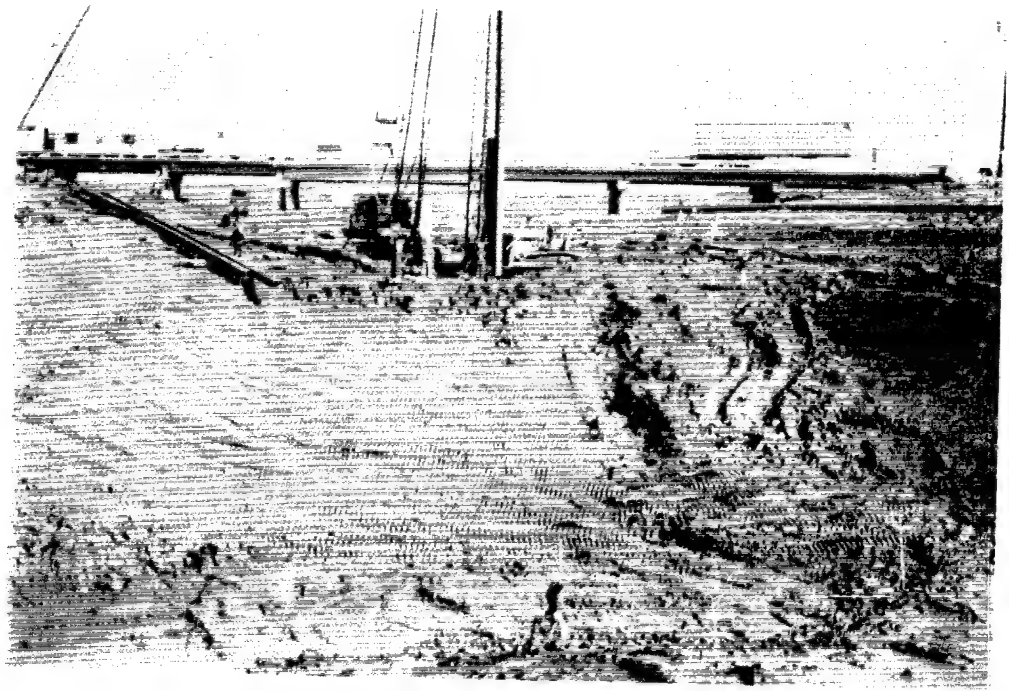
5. DRIVING TEST PILING BENEATH THE APPROACH MONOLITH

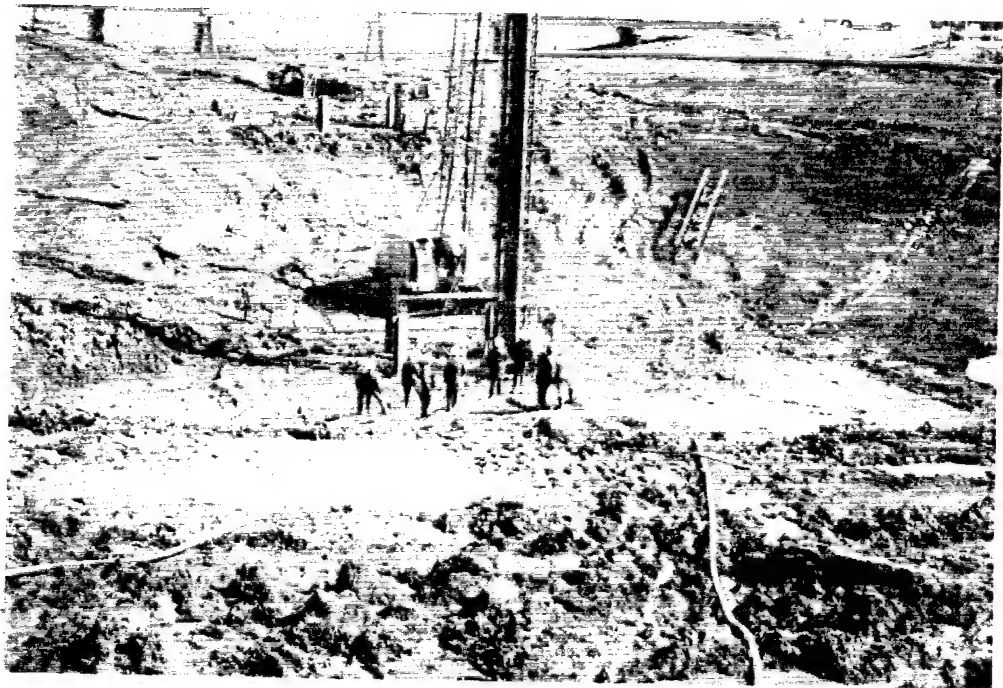
6. DRIVING TEST PILING BENEATH THE STILLING BASIN

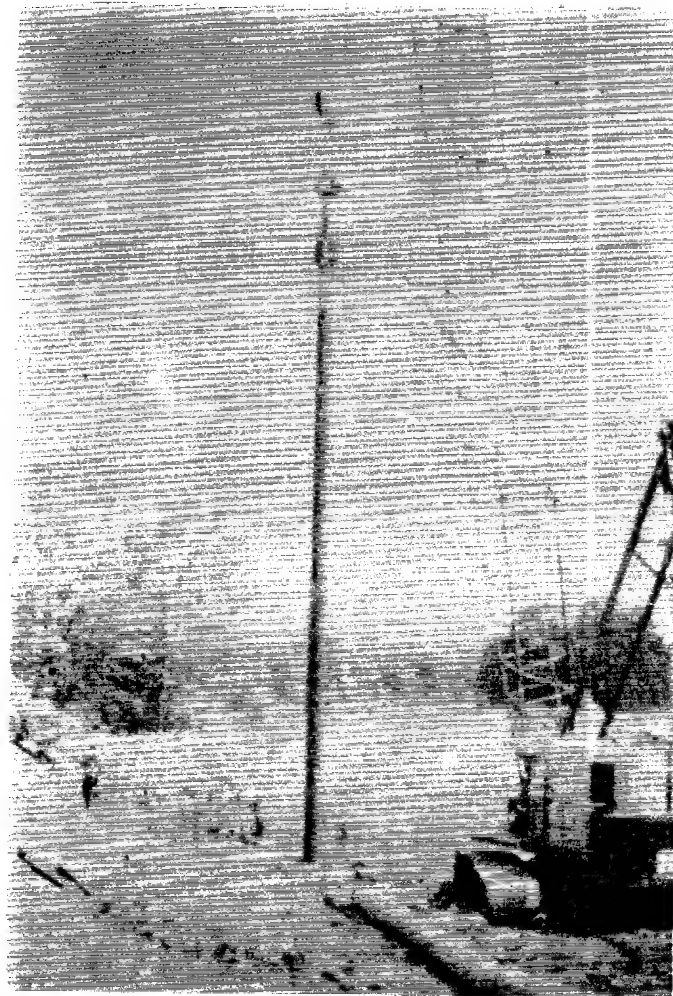
9. INSTALLATION OF DEWATERING WELL WITH JETTING TOOL.

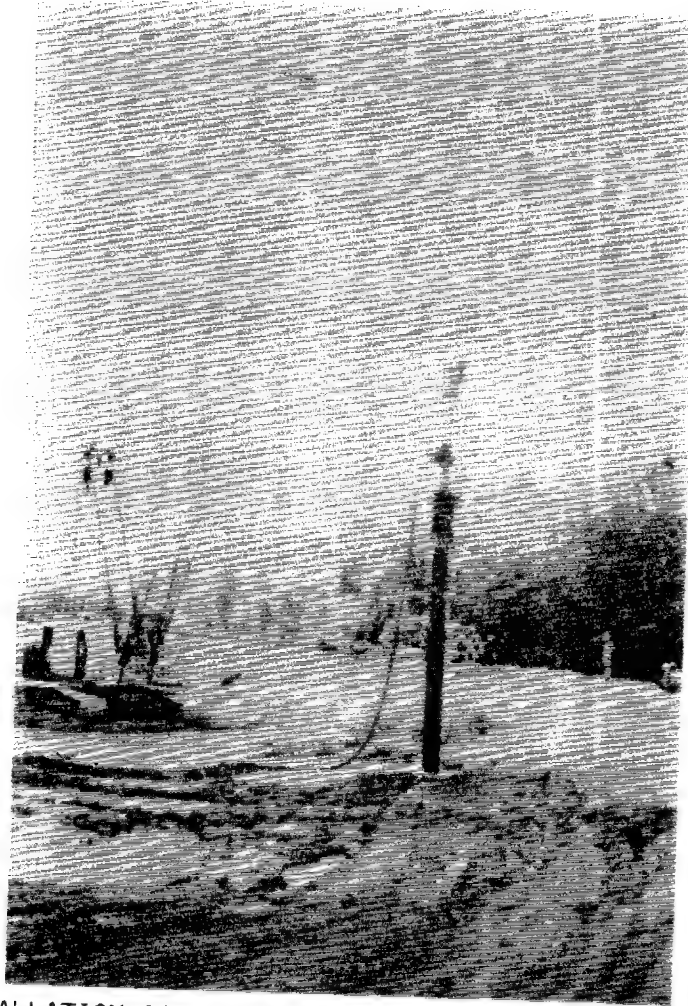
10. INSTALLATION OF DEWATERING WELL WITH JETTING TOOL

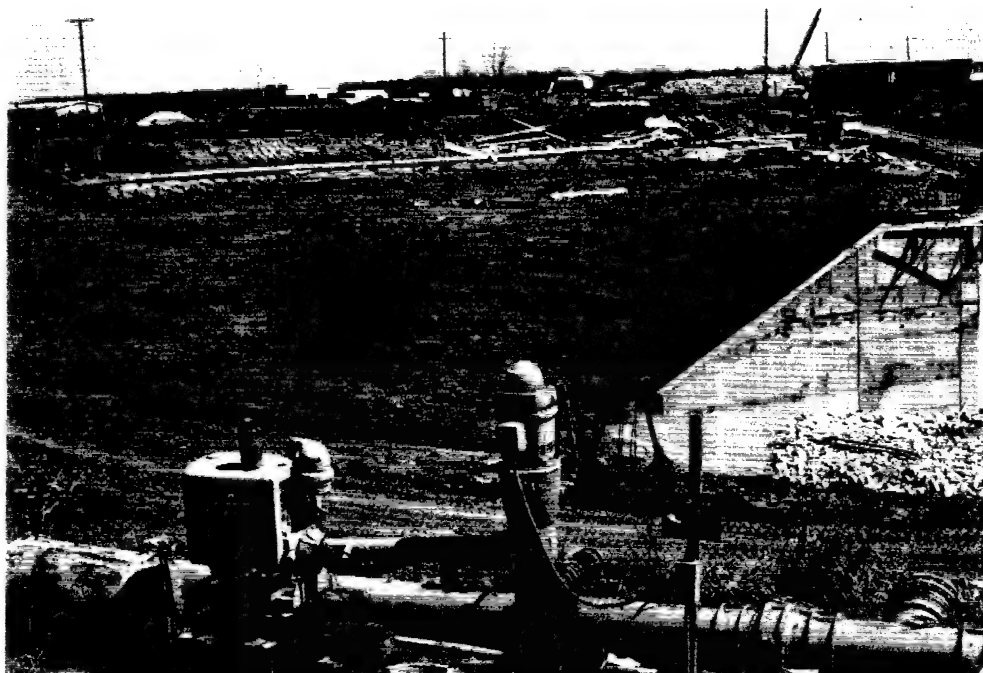
11. DEWATERING WELL #6, NOTE PRIMARY (ELECTRIC) AND BACKUP (DIESEL)

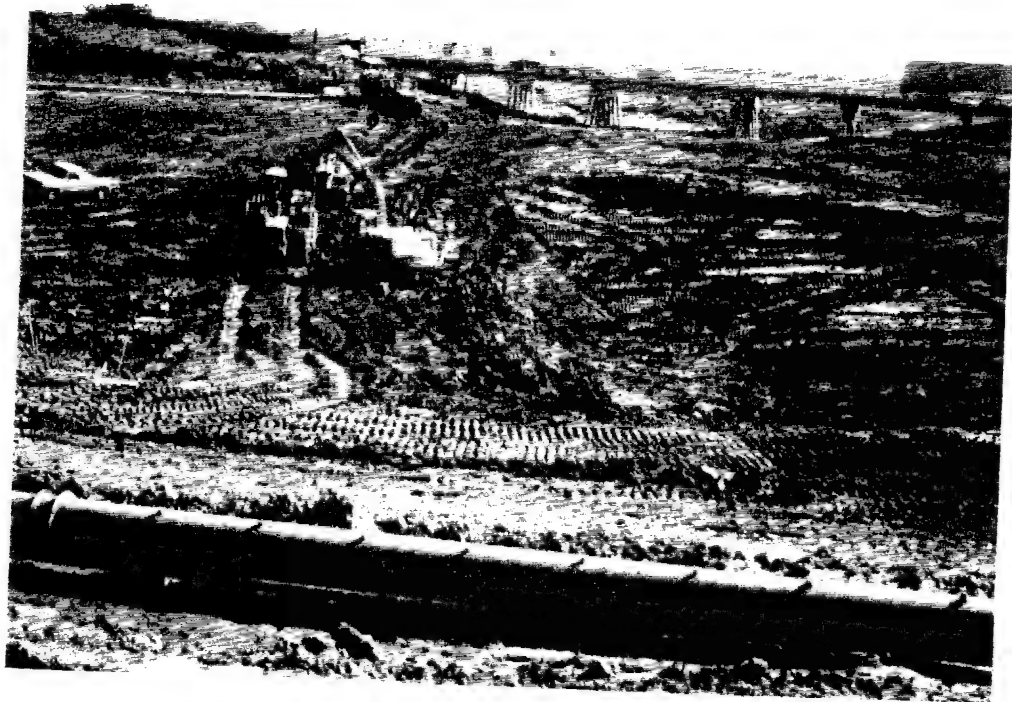
14. EARLY STRUCTURAL EXCAVATION

backfilling operation the impervious wedge failed along the backfill-excavation grade interface (Photographs 14 through 16). Investigations were performed by District and Greenwood Area Office personnel who concluded that the slide was a result of improper construction practices. The following construction methods are specifically noted as contributing factors:

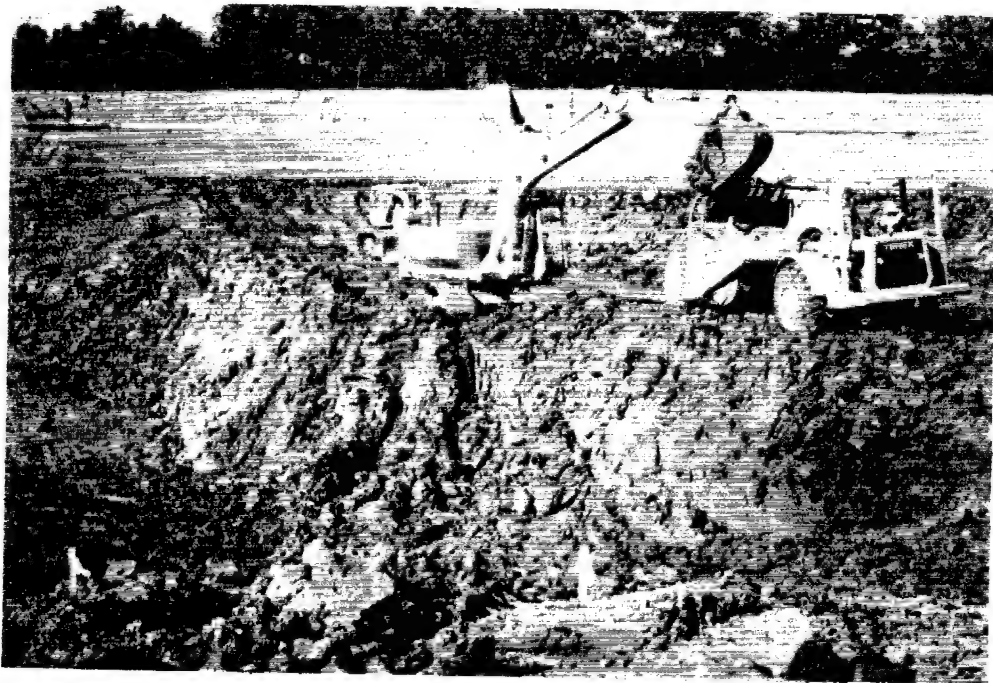
16. REMOVAL OF MATERIAL FROM IMPERVIOUS BACKFILL SLIDE

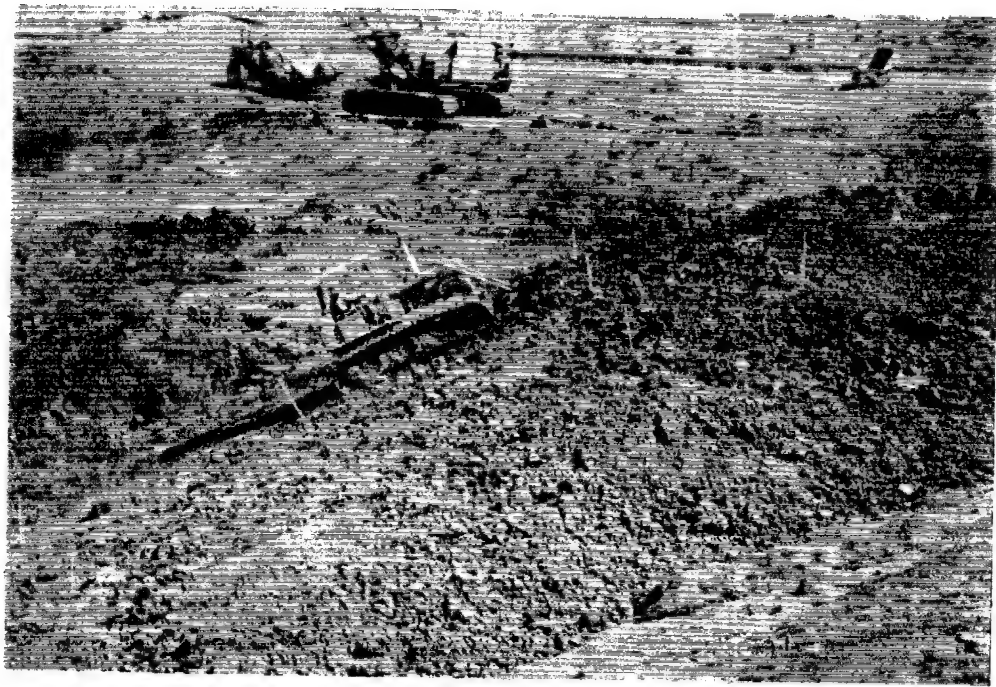
17. COMPACTING IMPERVIOUS BACKFILL NORMAL TO 1 ON 2 SLOPE

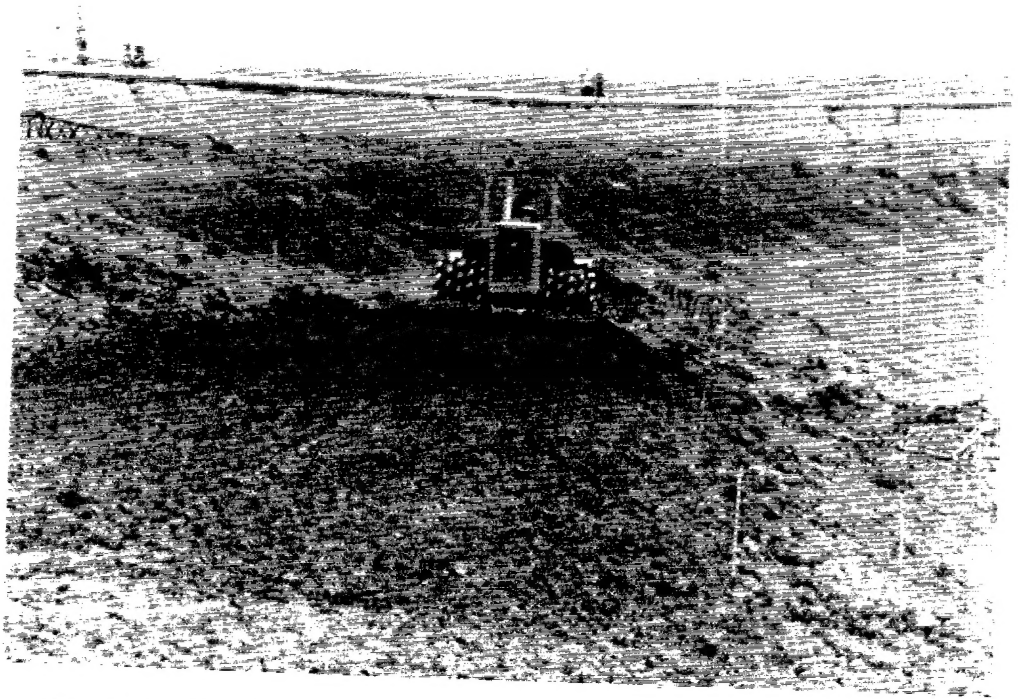
19. COMPACTING IMPERVIOUS BACKFILL IN HORIZONTAL LIFTS

The Contractor was instructed to repair the slide. The required 1-on-3 slope was reestablished, and the impervious backfill was placed as per contract specifications (Photographs 18 and 19). Unfortunately, no attempt was made to ensure that the failure surface was removed and the impervious backfill wedge failed a second time. Field investigations revealed that the

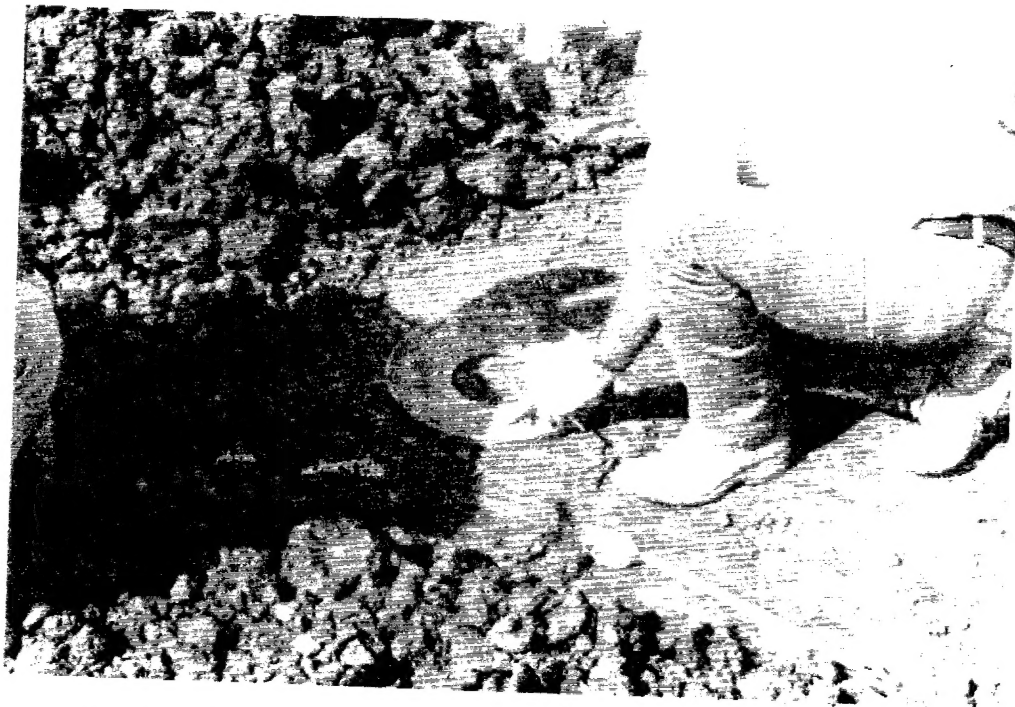
20. PERFORMING FIELD DENSITY TESTS-IMPERVIOUS BACKFILL

second slide resulted from movement on the original failure surface which had not been removed (Photographs 20 and 21). All disturbed material was then removed and the impervious fill was reconstructed as shown on Plate 13. No further problems were encountered.

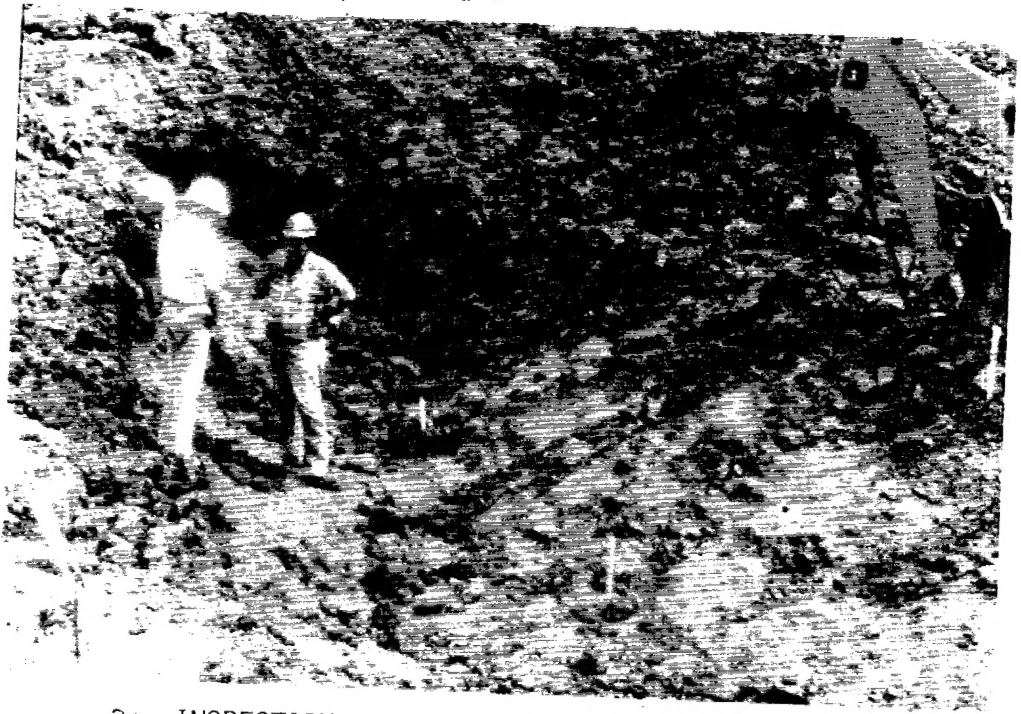
21. INSPECTION TRENCH-IMPERVIOUS BACKFILL

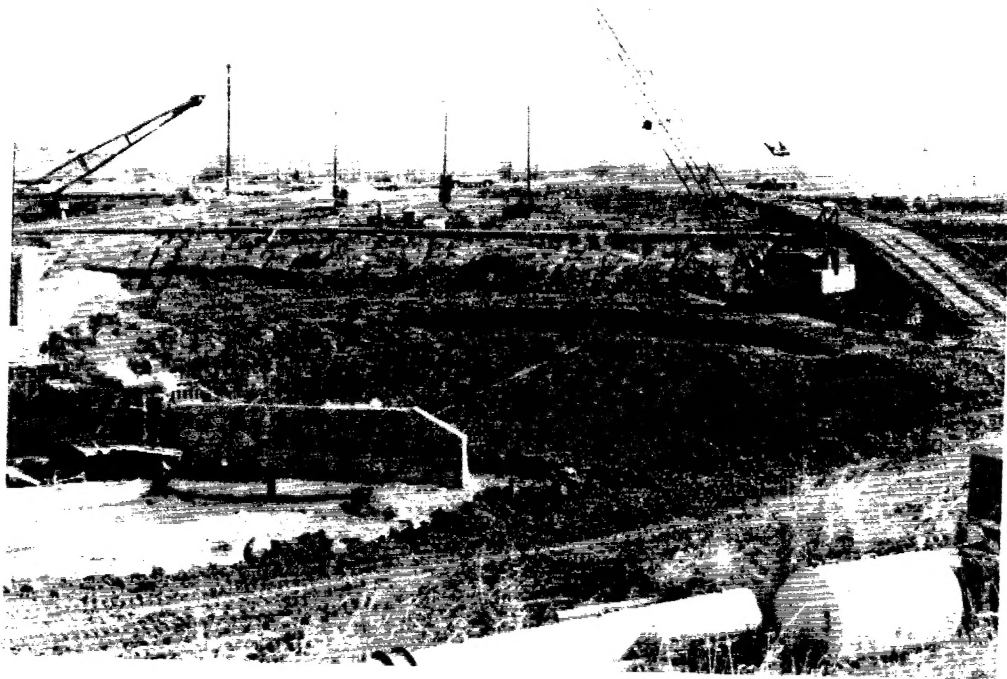
22. SLIDE IN RANDOM BACKFILL MATERIAL

a. General. Problems were experienced during the backfilling operation at the Ascalmore Creek-Tippo Bayou Control Structure. Slope failures occurred subsequent to backfilling areas beneath the approach and gated/drop monoliths (impervious backfill) and south of the riverside retaining wall (random backfill).

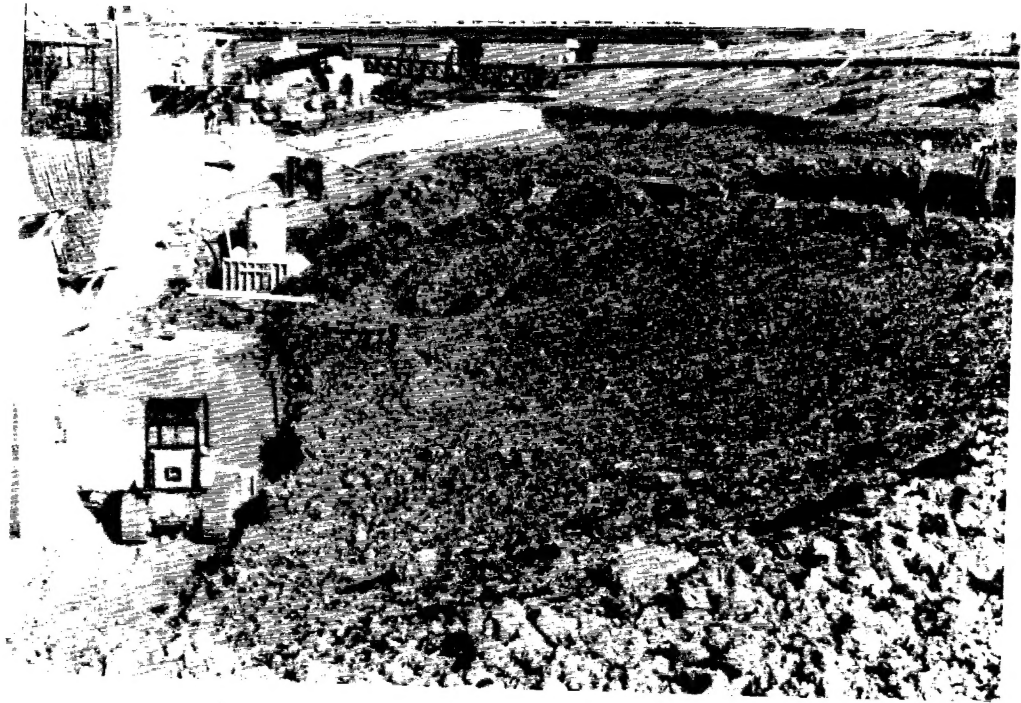
23. RANDOM BACKFILL SLIDE-NOTE ABSENCE OF PERVIOUS BACKFILL

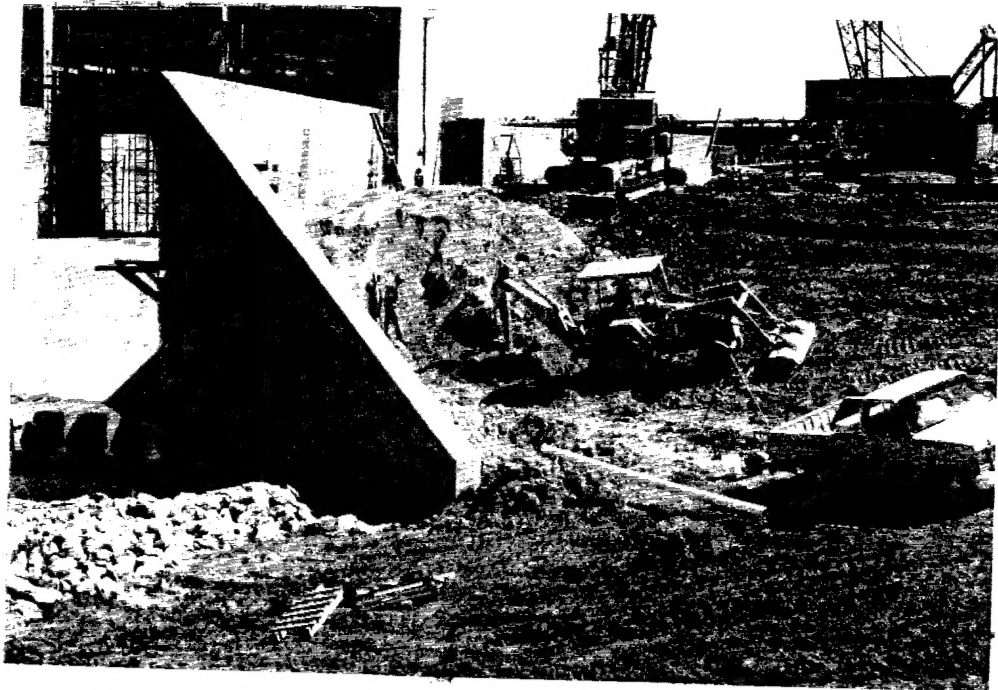
24. INSTALLATION OF COLLECTOR SYSTEM SOUTH RETAINING WALL

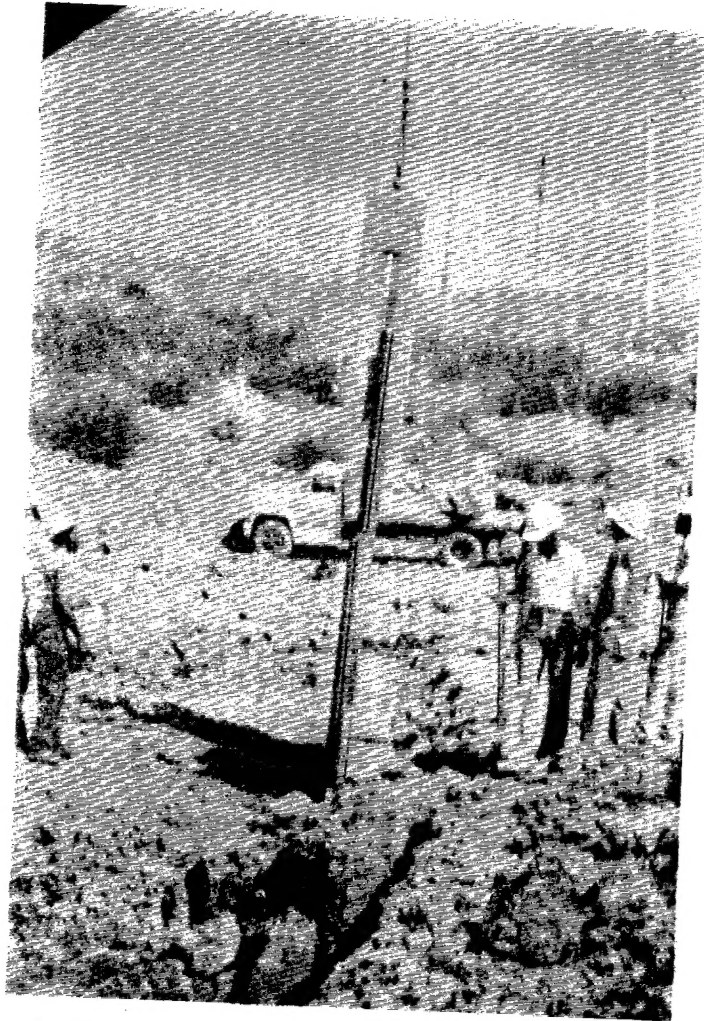
25. INSTALLATION OF SHEET PILE CUTOFF

Walls. Each riverside retaining wall (north and south) contains a 5-foot-deep sheetpile cutoff. These retaining walls are founded on battered H-piles, some of which are on the channel side of the sheetpile cutoff. It has been established that the phreatic surface in the alluvial-Sparta aquifer does not fall below elevation 122. Therefore, during low river stages and especially during periods when the structure is unwatered, ground water could migrate along the foundation piles and lead to piping and the development of subgrade cavities beneath the riverside retaining wall.
